SERVICE BULLETIN

Classification: EL03-030f	Reference: NTB03-074f	Date: February 21, 2012
------------------------------	--------------------------	----------------------------

EXTERIOR LAMP FOGGING

APPLIED VEHICLES: 2001-2012 Nissan, All Models

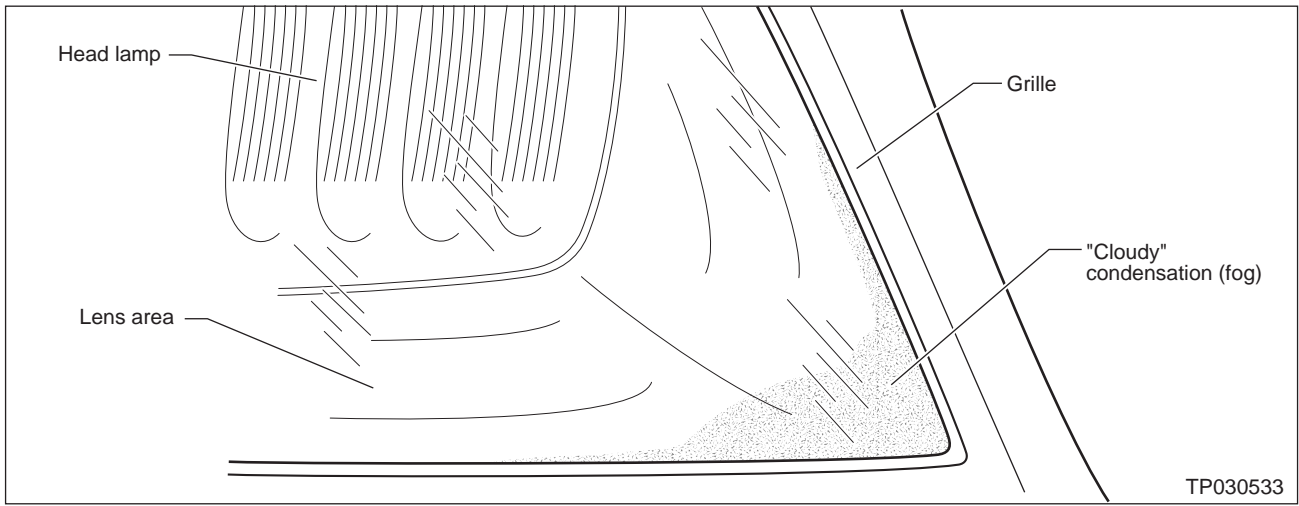
Fog may temporarily form inside the lens of the exterior lamp assemblies based on environmental conditions or sudden temperature changes (such as in a car wash, or parked on a cold, sunny day). This is normal. See Figure 1.

Figure 1: Example of normal condensation, ok

NOTE: This condensation can appear anywhere on the outer lens, typically at its coldest location.

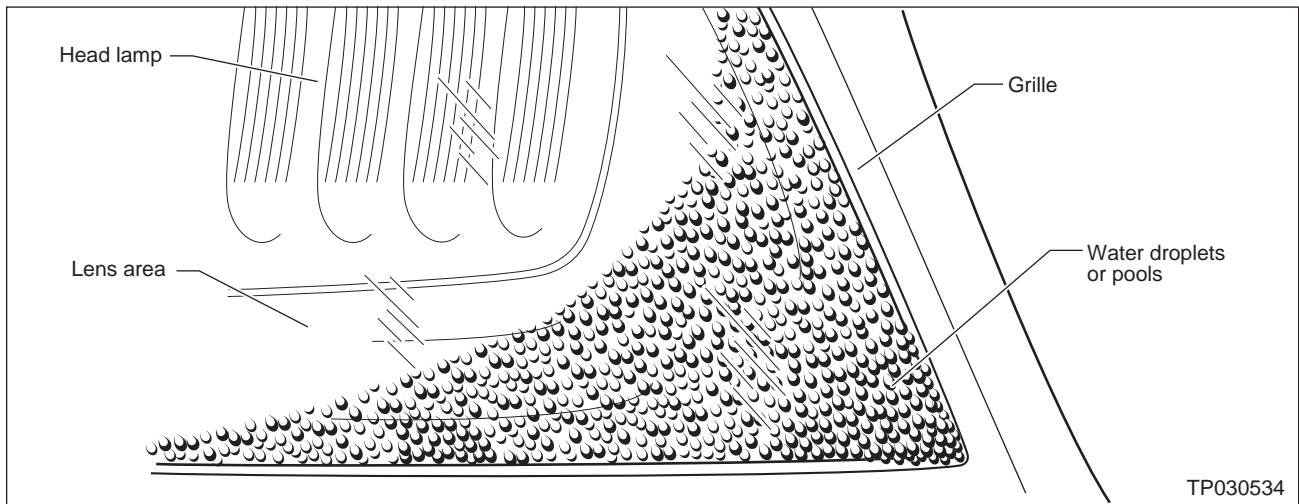
Figure 2: Condition may not be normal

If the moisture trickles, drips, or pools, it may not be considered normal and the lamp assembly may have a water leak path. See Figure 2 for an example.

If large drops of water collect inside the lens, refer to the flow chart on page 3 to find the next step.
