SERVICE BULLETIN

Classification: FA10-006	Reference: NTB10-126	Date: October 21, 2010
-----------------------------	-------------------------	---------------------------

WHEEL BEARING COLLISION DAMAGE

APPLIED VEHICLES: All Nissan

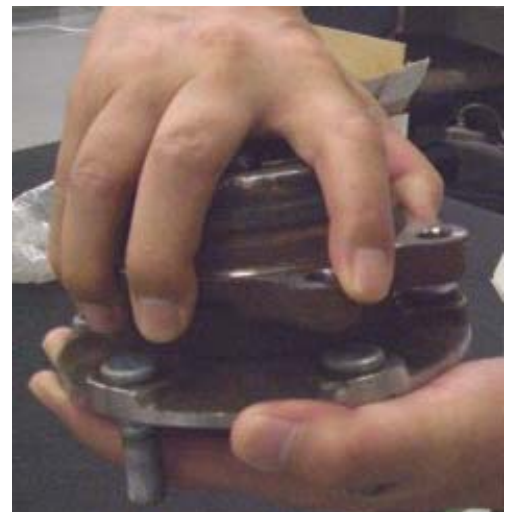
Impacts to wheel bearings (such as a collision or other suspension damage) may create slight indents in the bearing surfaces. These indents may not be visible but can cause bearing noise.

If a vehicle has visible wheel or suspension damage due to impact (collision or other suspension damage), it is recommended that the wheel bearing assembly be inspected as follows:

1. Remove the hub/bearing assembly from the vehicle.
2. Hold the hub/bearing assembly with both hands.
3. Rotate the hub/bearing assembly in both directions (clockwise and counterclockwise).
4. If any gritty or rough feeling is detected in the bearing replace it with a new one.
