SERVICE BULLETIN

Classification: EC10-037	Reference: NTB10-149	Date: December 22, 2010
-----------------------------	-------------------------	----------------------------

2009-2010 370Z; MIL `ON` DTC P1421 (COLD START CONTROL)

APPLIED VEHICLE: 2009 – 2010 370Z (Z34) Coupe
 2009 – 2010 370Z (Z34) NISMO Coupe
 2010 370Z (HZ34) Roadster

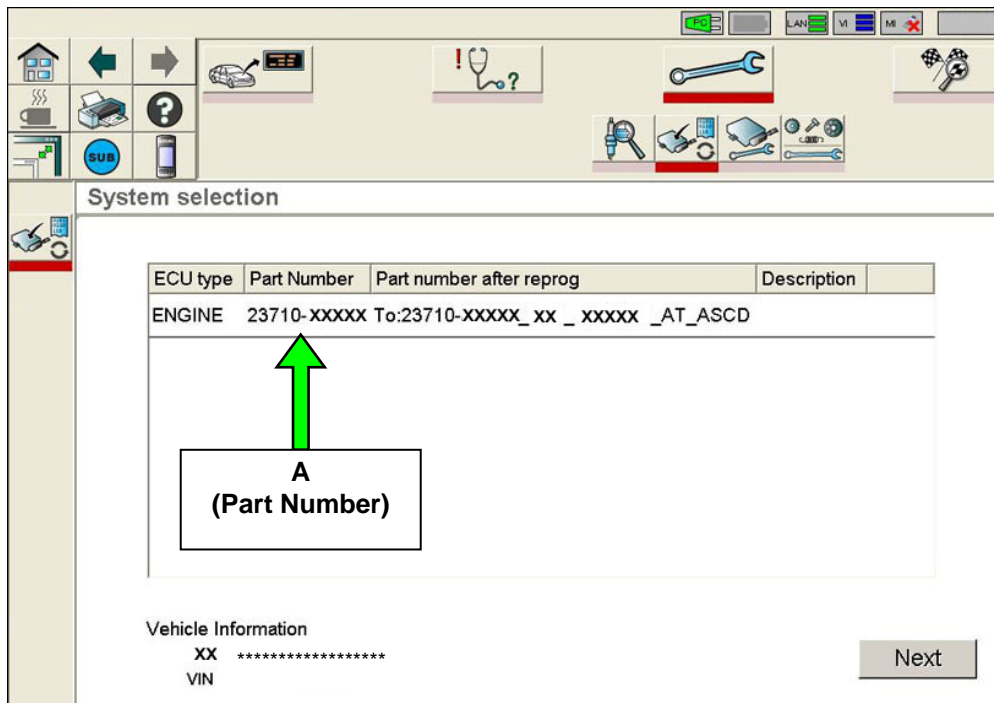
Figure 1

2. When you get to the ECM Reprogramming screen shown in Figure 1, confirm this bulletin applies as follows.

A. On your C-III screen, look at the **Part Number** column (see Figure 1):

- If this column is **blank** (no part number listed), this **bulletin does not apply**. Close C-III and refer to ASIST for further diagnostic information.
- If a Part Number is listed, write it on the Repair Order.

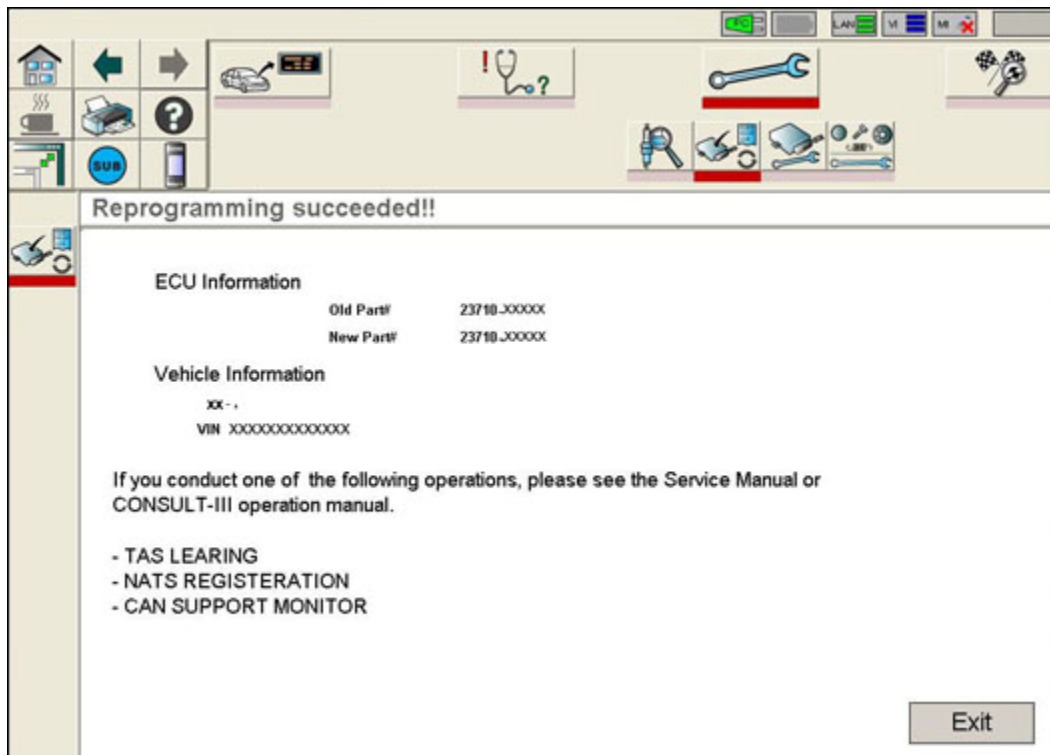
3. If this bulletin applies and you have performed ECM reprogramming, the screen in Figure 2 appears when reprogramming is complete.

NOTE: If the screen in Figure 2 does not display (reprogramming does not complete), click [here](#). This links to the ECM Reprogram Interruption Recovery General Procedure.

- **Print this screen and attach it to the Repair Order for Warranty documentation.**
