# SERVICE BULLETIN

Classification: BT10-041	Reference: NTB10-146	Date: December 17, 2010
-----------------------------	-------------------------	----------------------------

## 2010 – 2011 370Z ROADSTER DOOR WINDOWS CONTACTING SOFT TOP

**APPLIED VEHICLES:** 2010 – 2011 370Z (Z34)

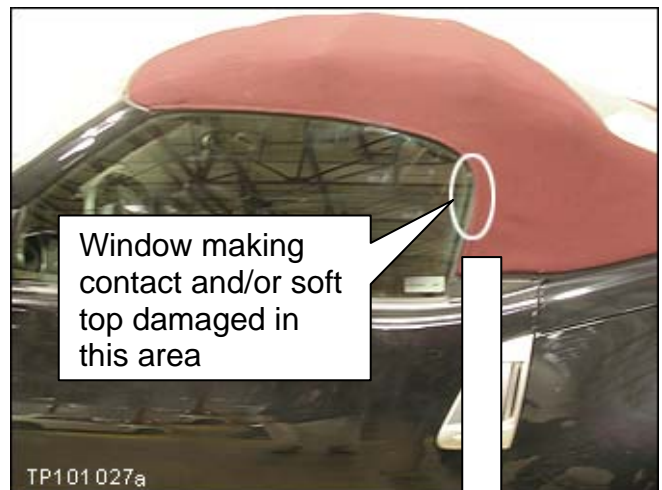
The soft top fabric is frayed (damaged) near a door window (left or right side) in the location shown in Figure 1.

The window is making contact with the soft top fabric when the door is opened or closed (see Figure 1 and Figure 1A),

Refer to the service procedure on page 3.

#### a. Replace the soft top fabric (cover).

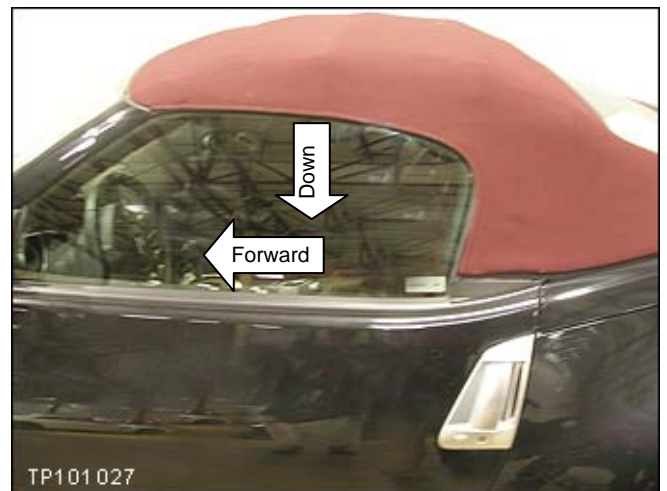
Figure 2

If a door window rubs (contacts) the soft top fabric when opening and closing the door, adjust the window down and forward just enough to prevent the window from contacting the fabric.

See Window Adjustment on the next page.

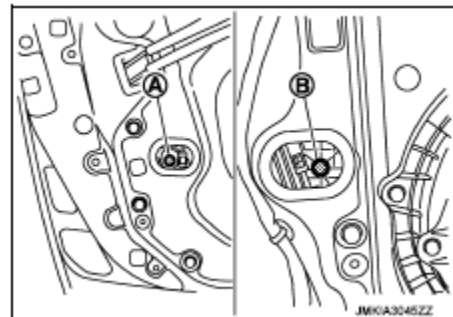
**NOTE:** The bolt holes are elongated. This will allow enough movement/adjustment to prevent the window from contacting the soft top fabric.

8. Operate the power window up or down as needed to access the bolts (A & B) shown in Figure 3.

9. Loosen the bolts (A & B) shown in Figure 3 just enough to allow window movement/adjustment.

10. Adjust the window down and forward just enough to prevent the window from contacting the soft top.
