SERVICE BULLETIN

Classification: EL11-038	Reference: NTB11-096	Date: October 19, 2011
-----------------------------	-------------------------	---------------------------

iPOD® / iPHONE® ISSUES USING VEHICLE USB INTERFACE

APPLIED VEHICLES: All Nissan vehicles equipped with a USB Interface

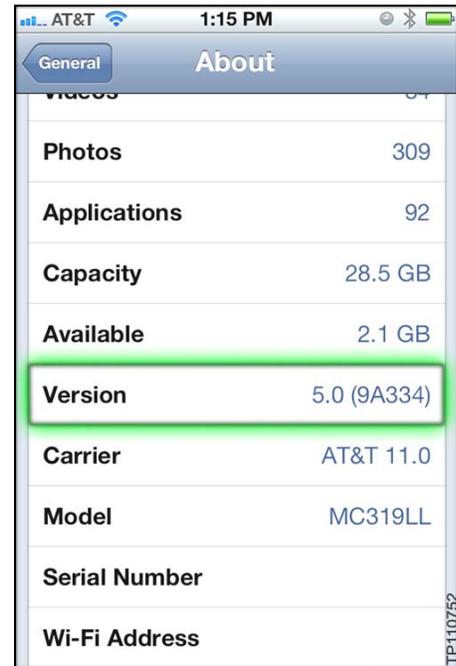
3. Confirm the latest software is installed on the iPod® / iPhone®

- Many concerns are addressed by installing the latest iPod® / iPhone® software update from Apple Inc.
- View the software version of the iPod® / iPhone® by navigating to the **Settings** area of the device, then selecting **General > About** or **Settings**.
- Visit <http://support.apple.com/downloads> and select the applicable device to view the latest software update offered by Apple Inc.
