# SERVICE BULLETIN

Classification: EC12-013	Reference: NTB12-053	Date: June 22, 2012
-----------------------------	-------------------------	------------------------

## 2010 – 2012 370Z; MIL “ON” WITH DTC P0106 STORED

**APPLIED VEHICLE:** All 2010-2012 370Z Coupe and Roadster (Z34/HZ34)

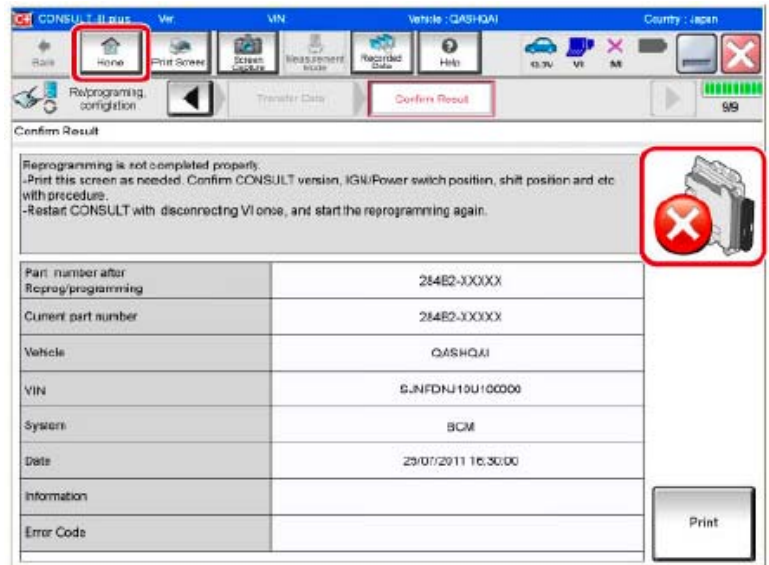
Figure 6

If reprogramming does not complete and the “X” icon displays as shown in Figure 6:

- Check battery voltage (12.0 – 15.5 V).
- CONSULT A/C adapter is plugged in.
- Ignition is ON, engine OFF.
- Transmission is in Park.
- All C-III plus / VI cables are securely connected.
- All C-III plus updates are installed.
- **Select Home, and restart the reprogram procedure from the beginning.**
