SERVICE BULLETIN

Classification: EL12-060	Reference: NTB12-070	Date: January 9, 2013
-----------------------------	-------------------------	--------------------------

2010 – 2013; NAVIGATION SOFTWARE UPDATE

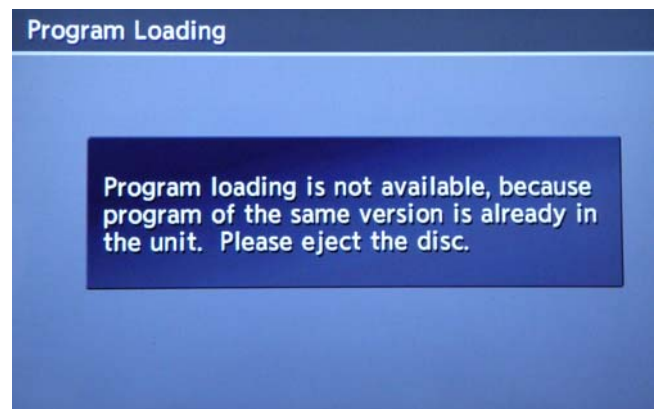
Figure1

- If the screen in Figure 1 is displayed, this update has already been performed and this bulletin does not apply.
 - Turn the Bluetooth back ON and remove the DVD from the CD slot.

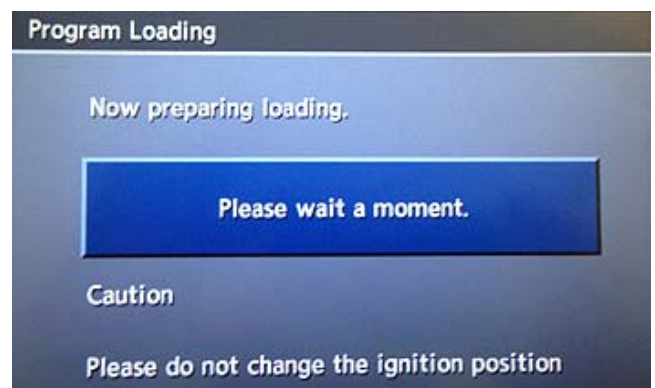
- If “Now preparing loading” shown in Figure 2 is displayed, follow the on screen Caution while the Navigation is updated.

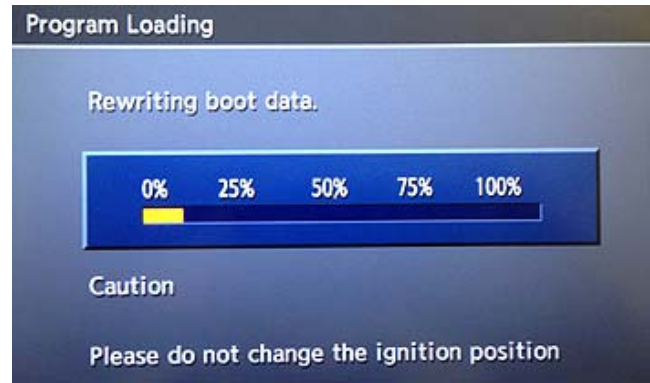
Figure 3

7. During the first part of the update process 3 more screens will be displayed along with a percentage of completion (progress) bars:
- Rewriting boot data. (Figure 3)
 - Rewriting program data (Figure 4)
 - Rewriting language data (Figure 5)

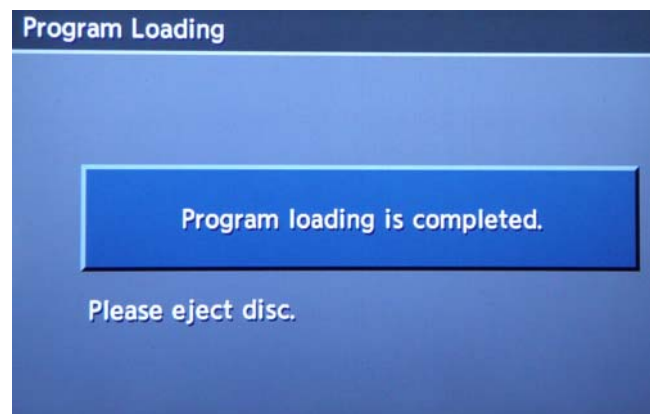
Figure 6

8. When the first part of the program has finished loading:
- "Program loading is completed" will be display (Figure 6).
 - The Re-programming Software DVD will automatically eject.
9. Remove the DVD and continue to the second part of the update in step 10.

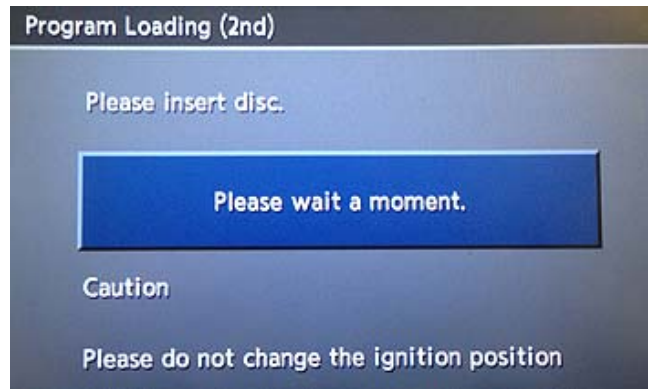
10. After the DVD is removed, the screen in Figure 7 “Please insert disc” may ask to reinstall the **same** Re-programming Software DVD for a second time.

- If not, the re-programming is complete. Proceed to step 13.
- If so, re-insert DVD disc.
 - At the top of the screen “Program Loading (2nd)” will be displayed.

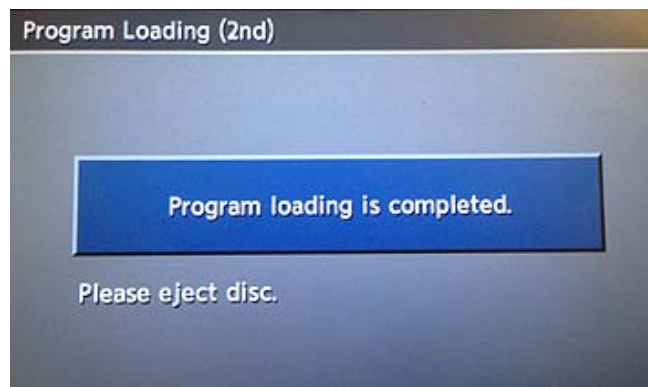
Figure 10

- “Program loading is completed” will be display (Figure 10).
- The Re-programming Software DVD will automatically eject.
- The Navigation system will restart.
- Proceed to step 13.
