# SERVICE BULLETIN

Classification: EL11-043b	Reference: NTB11-103b	Date: October 31, 2012
------------------------------	--------------------------	---------------------------

## PREMIUM NAVI / AUDIO VISUAL CONTROL UNIT DIAGNOSIS AND ORDERING

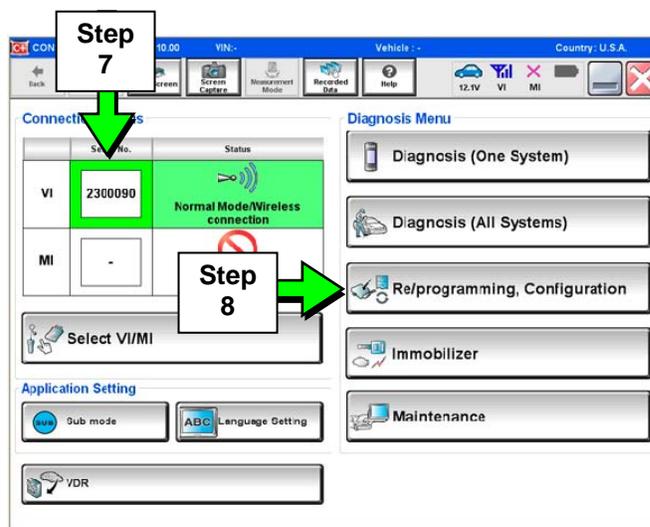
Figure 1

6. Wait for the plus VI to be detected, and the status box(es) to turn "green".
7. Select the plus VI with the correct serial number being used (if more than one in the shop) by highlighting it in the **Connection Status** box.
8. Select **Re/programming Configuration**.

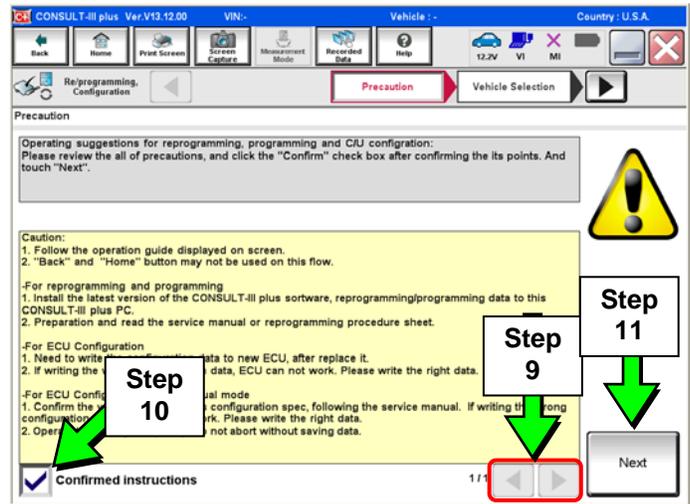
Figure 2

9. Use arrows (if needed) to view and read all **Cautions**.

10. Check the box confirming the precautions have been read.

11. Select **Next**.

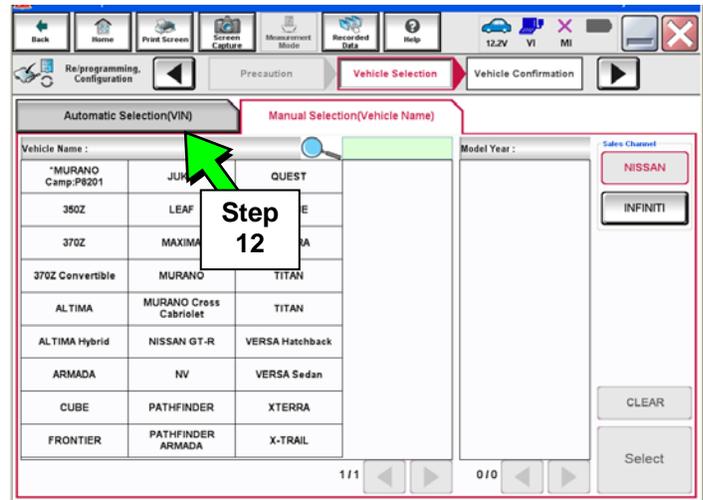
Figure 3

12. Select the **Automatic Selection(VIN)** tab.

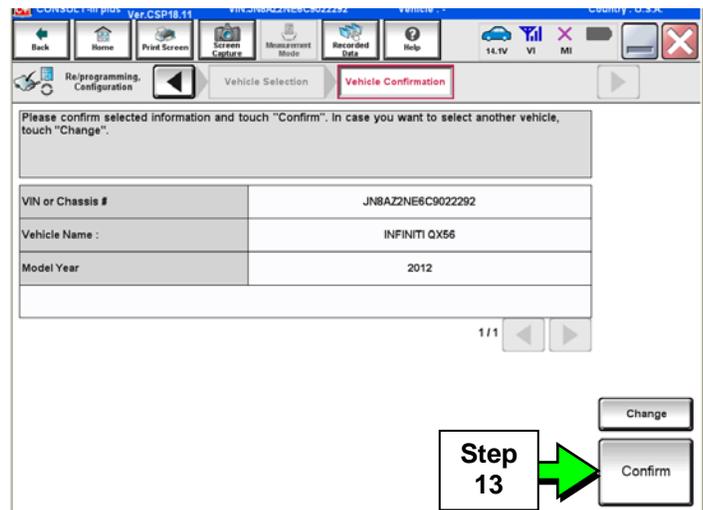
Figure 4

13. Select **Confirm**.

- Wait while system call completes.

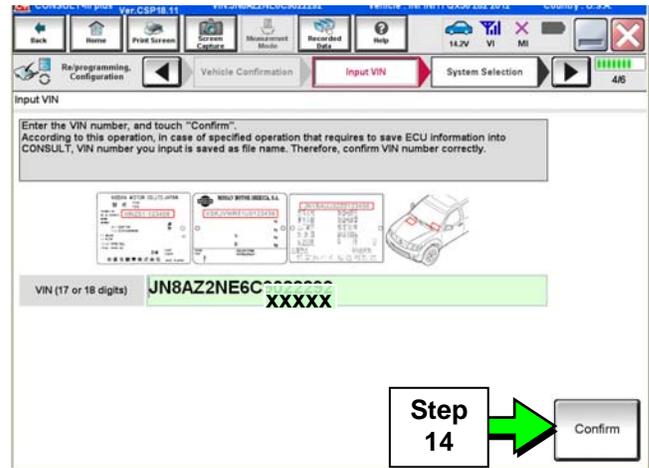
Figure 5

14. Select **Confirm**.

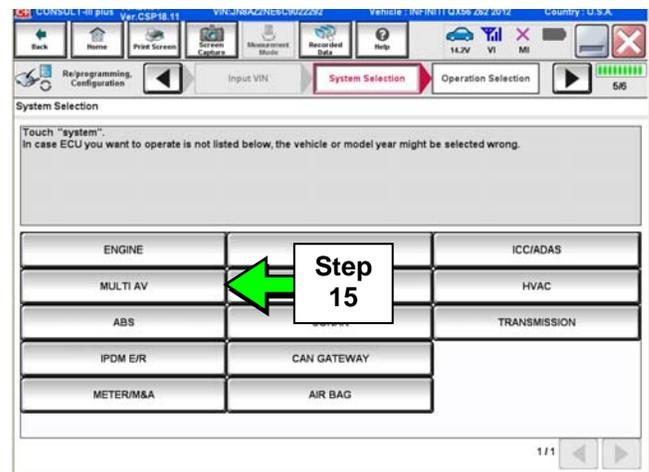
Figure 6

15. Select **Multi AV**.

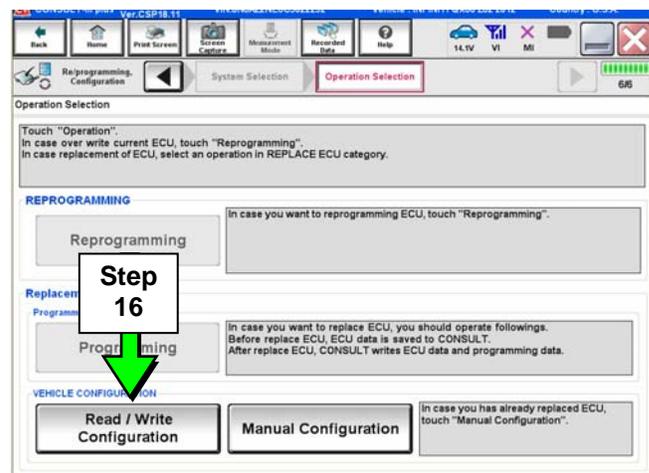
Figure 7

16. Select **Read / Write Configuration**.

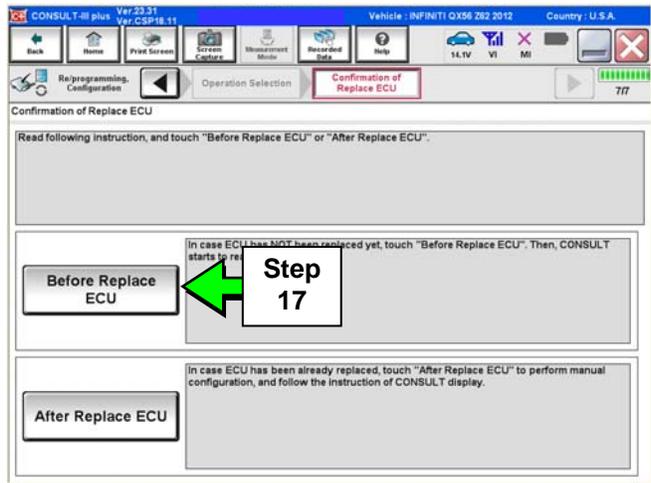
Figure 8

17. Select **Before Replace ECU**.

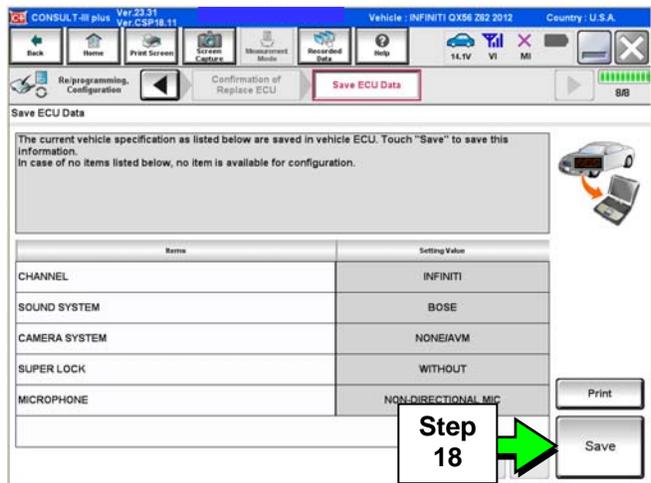
Figure 9

18. Select **Save**.

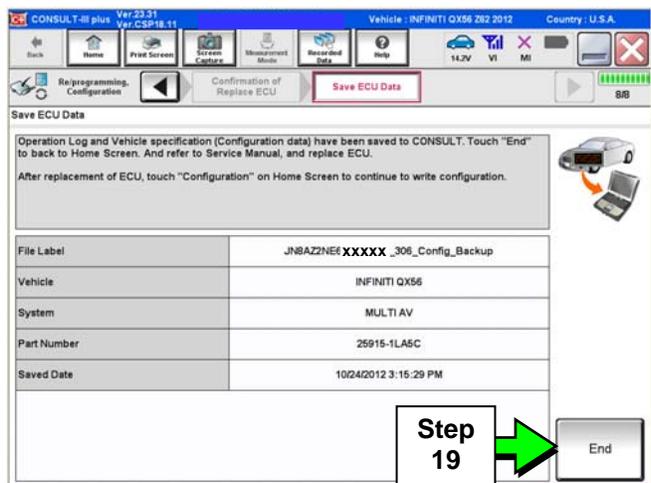
Figure 10

- The software P/N is shown in Figure 10. Ignore it.

19. Select **End**.

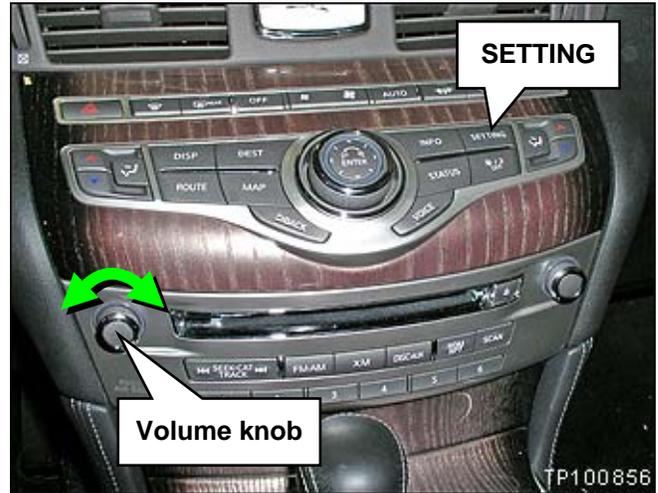
Figure 11

a. Press and hold the **SETTING** button.

b. While holding the **SETTING** button, turn the volume control knob 40 clicks or more.

- The volume control knob can be turned either direction.

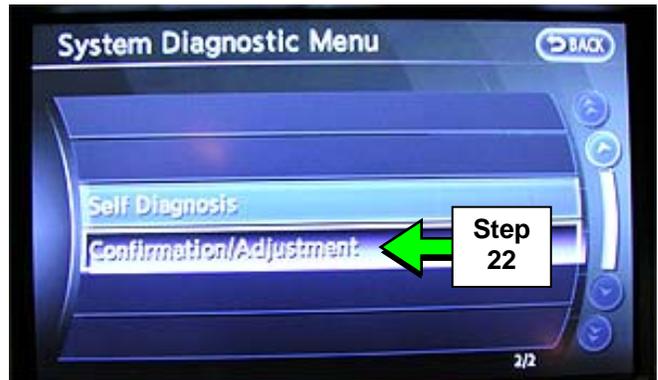
- When the system goes into the System Diagnostic Menu, the screen in Figure 12 will display.

22. Select **Confirmation/Adjustment**.

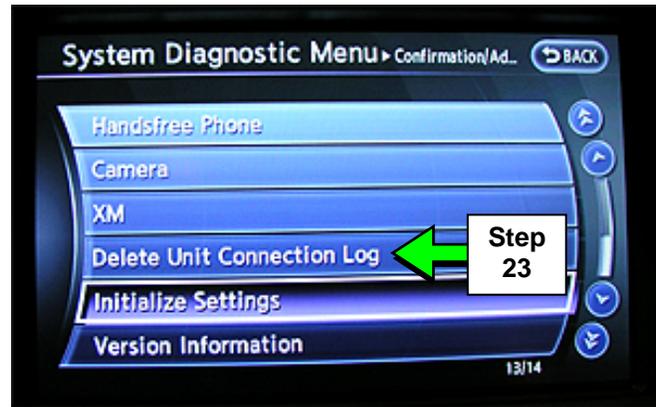
Figure 13

23. Select **Delete Unit Connection Log**.

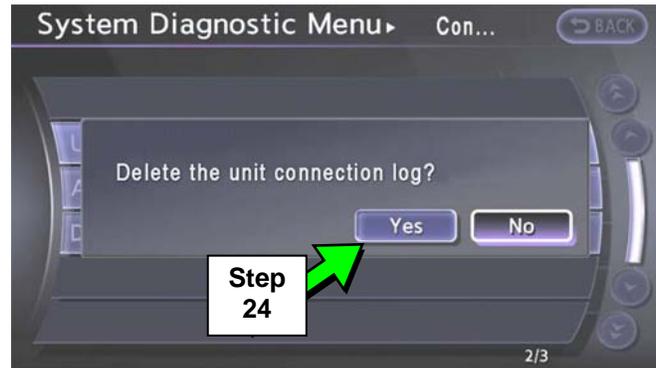
Figure 14

24. Select **Yes**.

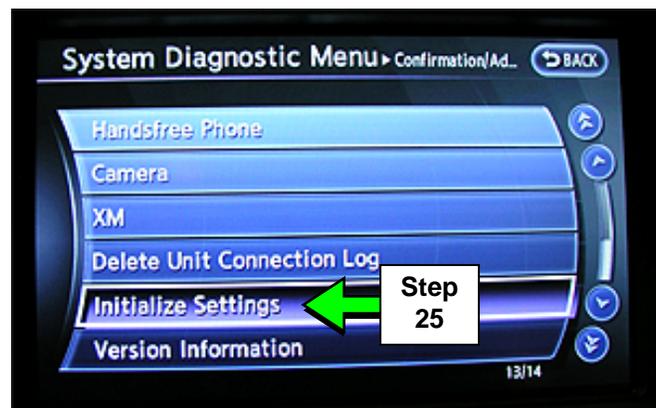
Figure 15

25. Select **Initialize Settings**.

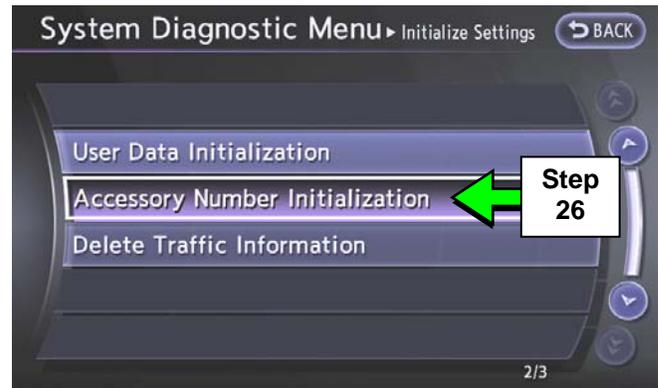
Figure 16

26. Select **Accessory Number Initialization**.

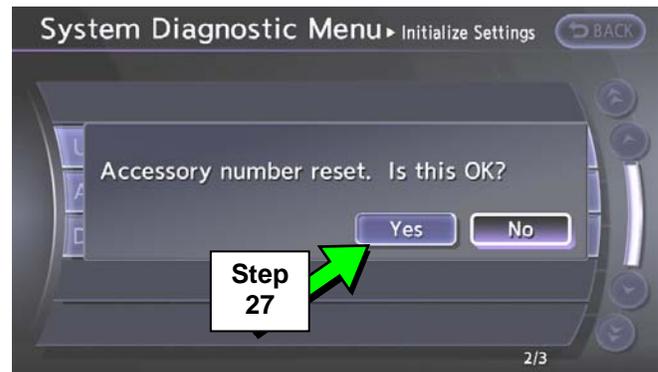
Figure 17

27. Select **Yes**.

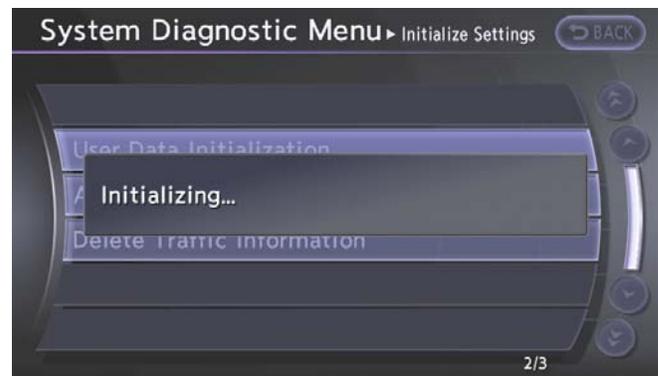
- The screen in Figure 18 will display while "initializing".

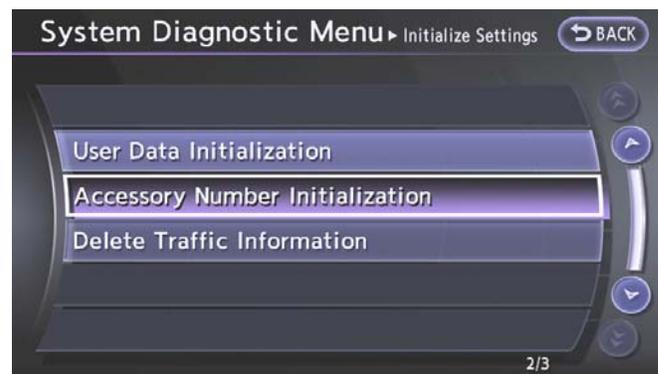
- The screen in Figure 19 will display when "initialization" is complete.

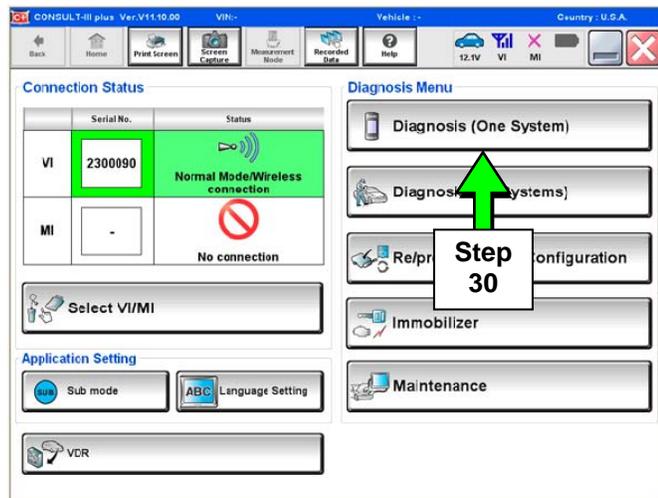
Figure 20

30. Select **Diagnosis (One System)**.

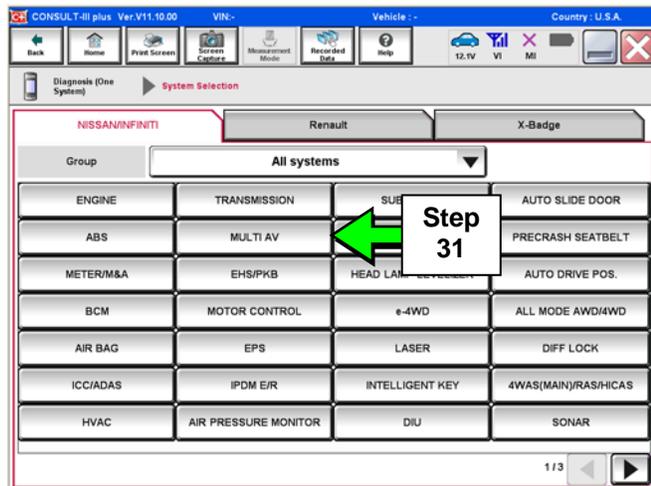
Figure 21

31. Select **MULTI AV**.

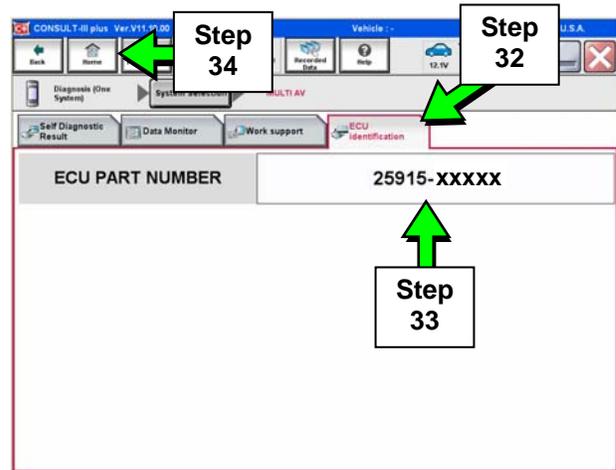
Figure 22

32. Select the **ECU identification** tab.
33. Print or write down the **ECU PART NUMBER** for ordering and warranty information:

25915-\_\_\_\_\_
34. Select **Home**.

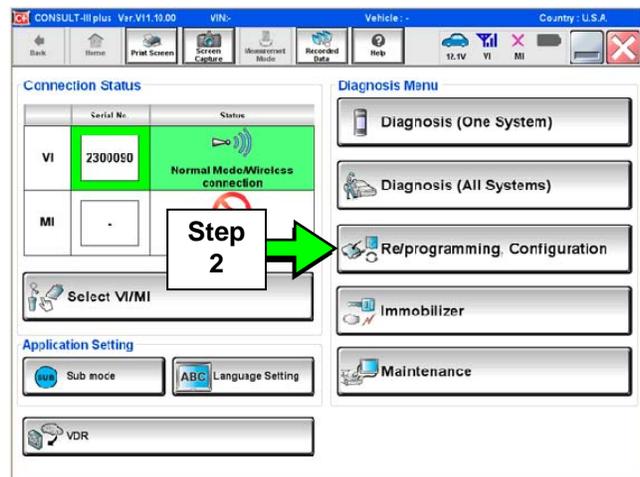
1. After selecting **Home**, the screen in Figure 23 will appear.
2. Select **Re/programming Configuration**.

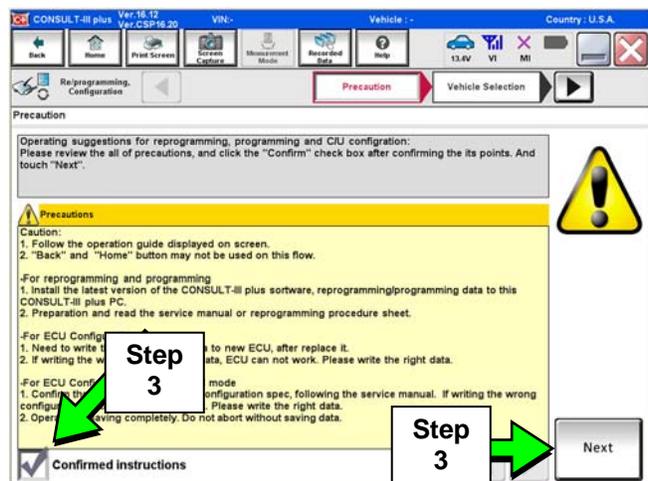
Figure 24

3. Read the **Precautions**.
  - When finished, touch the **Confirmed instructions** box to insert a check mark, and then select **Next**.

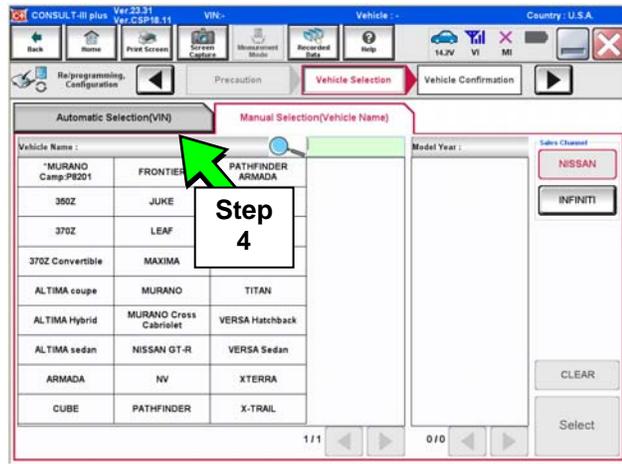
Figure 25

4. Select **Automatic Selection(VIN)**.

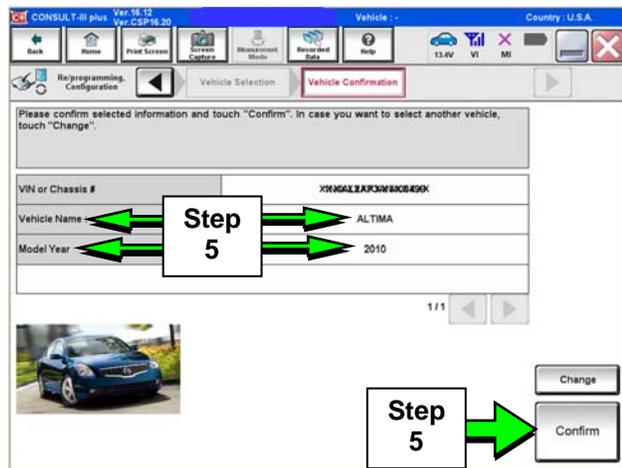
Figure 26

5. Confirm the correct **Model Name** and **Model Year** are displayed.

- When finished, select **Confirm**.

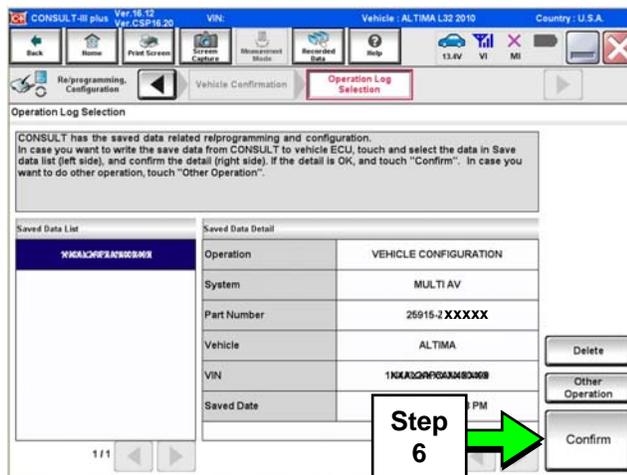
Figure 27

6. Select **Confirm**.

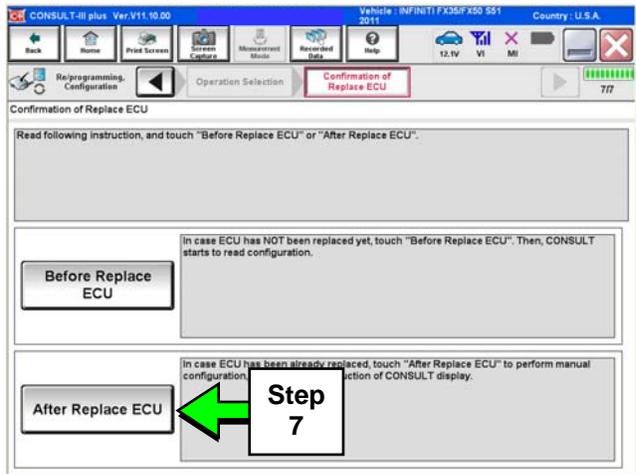
Figure 28

7. Select **After Replace ECU**.

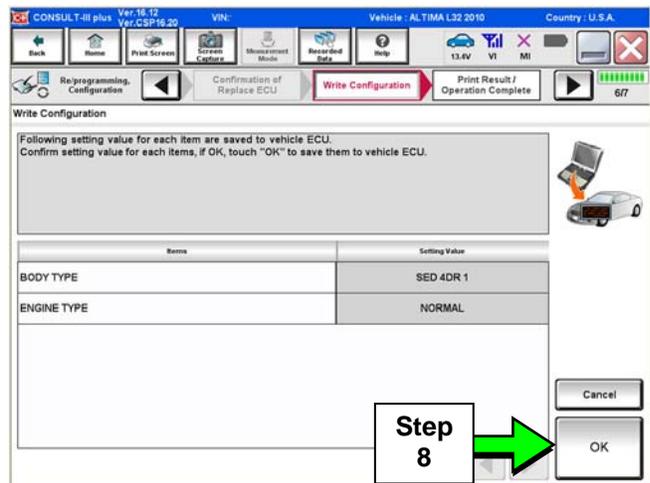
Figure 29

8. Select **OK**.

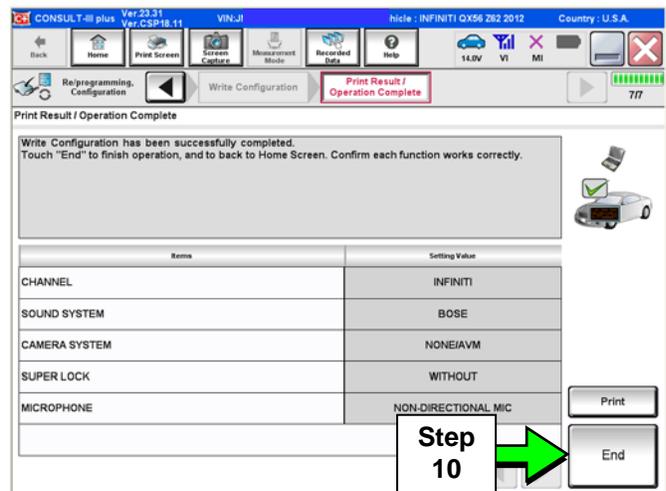
9. After selecting **OK**, the screen in Figure 30 appears.

10. Select **End**.

- Configuration is now complete.
