SERVICE BULLETIN

Classification: EL10-041e	Reference: NTB10-125e	Date: January 17, 2013
------------------------------	--------------------------	---------------------------

NAVIGATION AND AUDIO/VIDEO SOFTWARE UPDATE

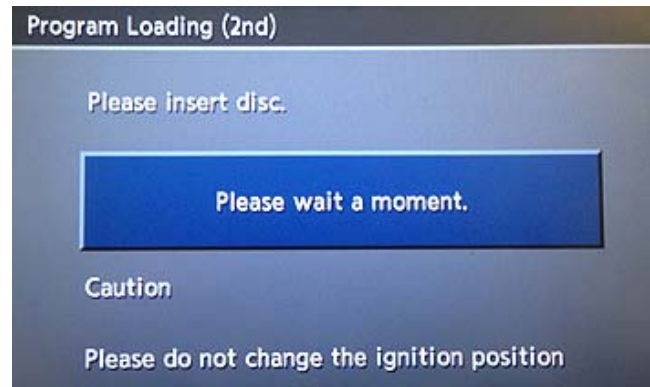
10. After the DVD is removed, the screen in Figure 7 “Please insert disc” may ask to reinstall the **same** Re-programming Software DVD for a second time.

- If not, the reprogramming is complete. Proceed to step 13.
- If so, re-insert DVD disc.
 - At the top of the screen “Program Loading (2nd)” will be displayed.
