SERVICE BULLETIN

Classification: EL12-015	Reference: NTB12-041	Date: April 27, 2012
-----------------------------	-------------------------	-------------------------

IGNITION SWITCH (PUSH BUTTON) WILL NOT RESPOND

APPLIED VEHICLES: 2011 – 2012 Altima Sedan, Coupe & Hybrid (L32, CL32, & L32HV)
2011 – 2012 Maxima (A35)
2011 – 2012 370Z Coupe (Z34) – Roadster not included
2011 – 2012 Murano (Z51) - Cross cabriolet not included
2012 GT-R (R35)

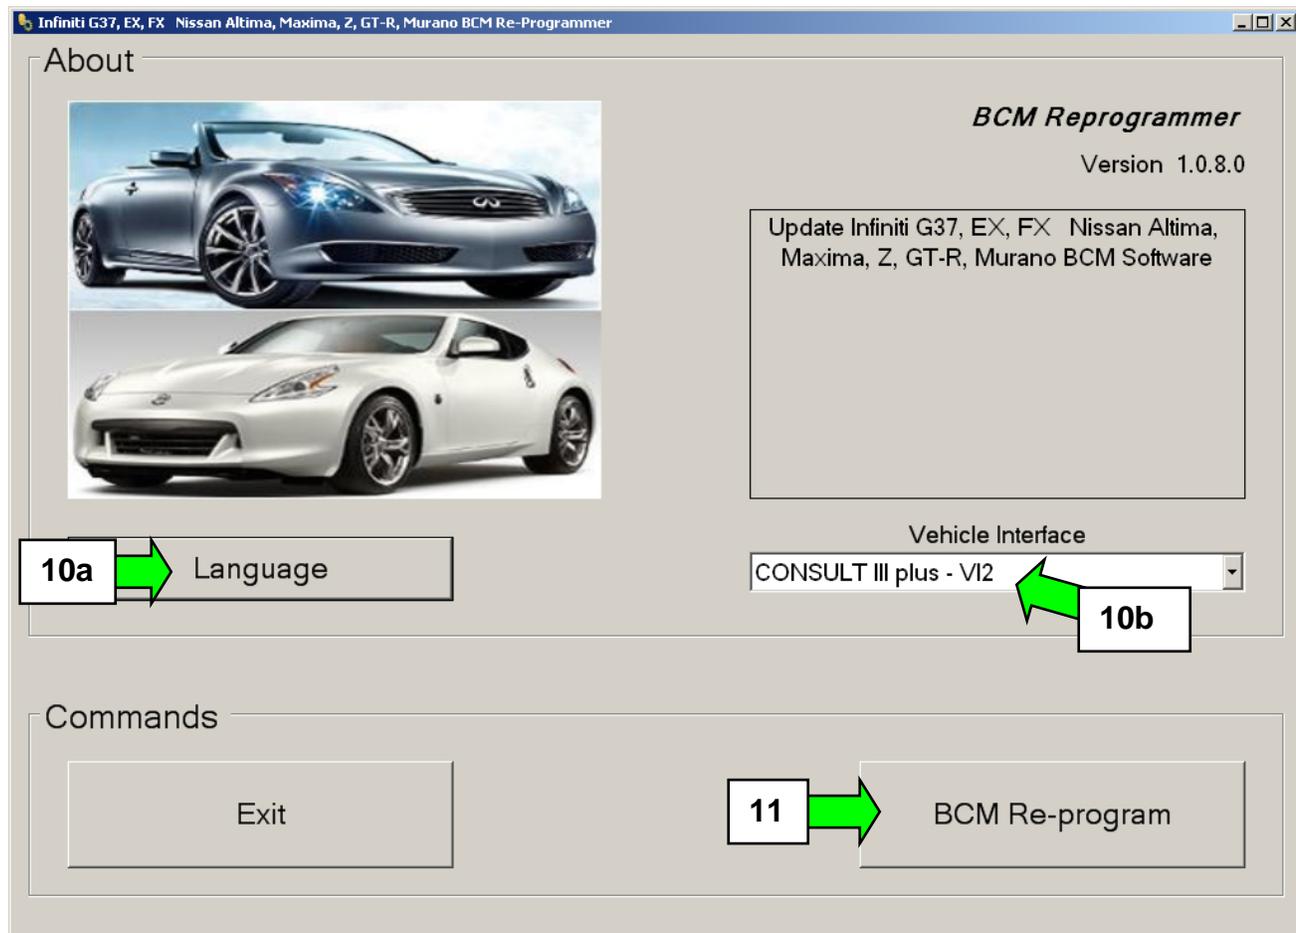
Figure 1

10. Make selections on the main screen (see Figure 1).

11. Select **BCM Re-program**

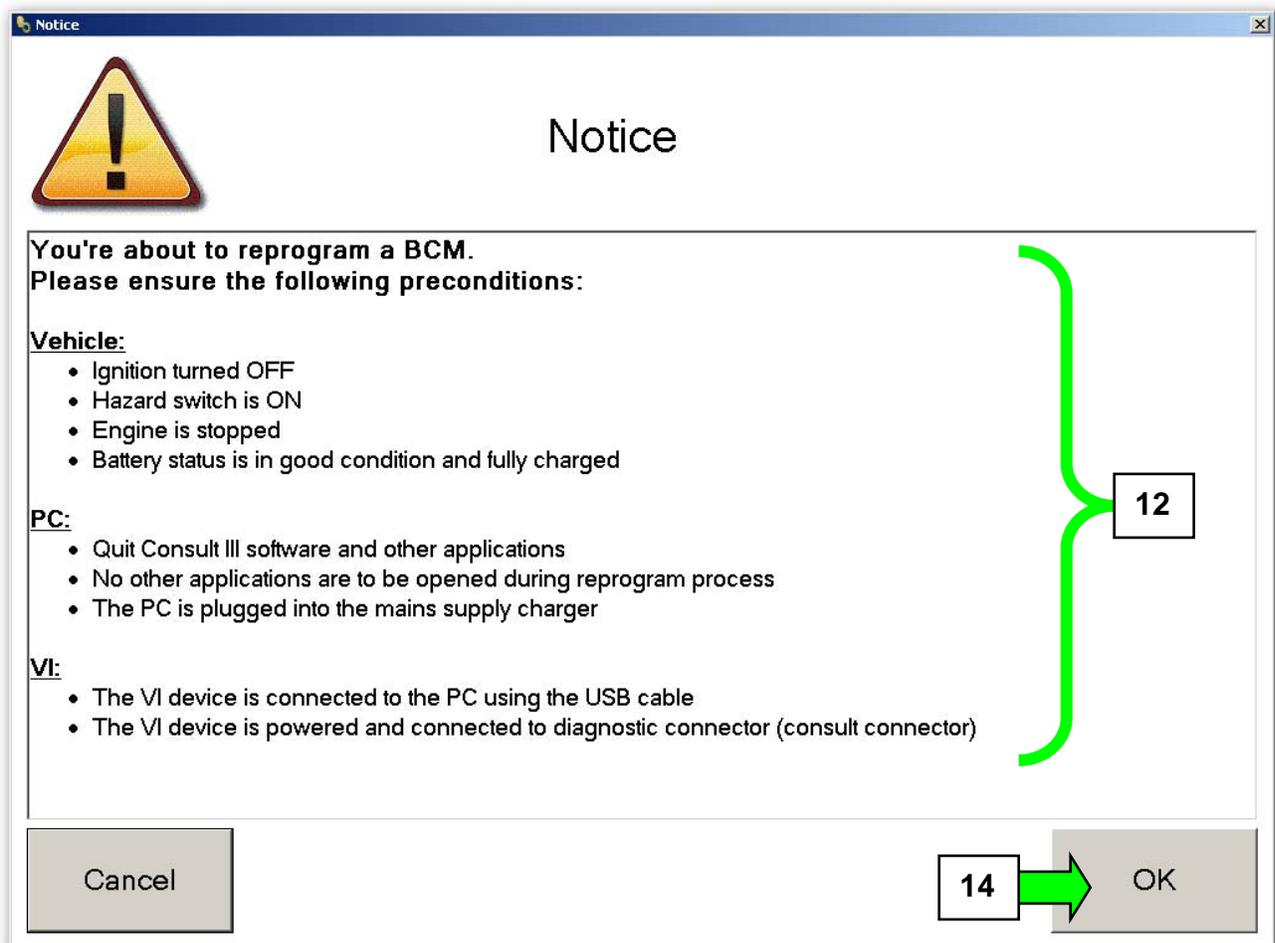
Figure 2

12. Make sure each of the preconditions listed on the screen have been met (see Figure 2).

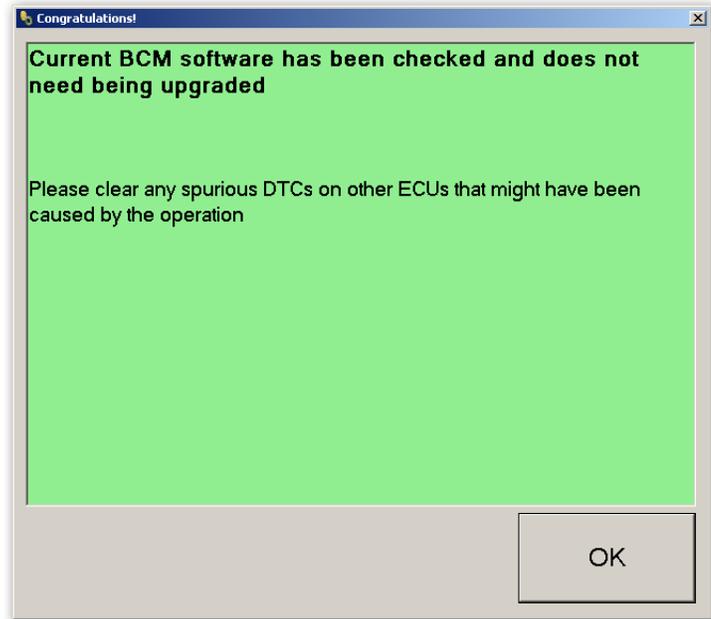
Error – BCM reprogramming is not needed for this vehicle.

- The reprogramming process will stop and the message in Figure 3 will display.
- Select OK, to return to the main screen and then select Exit.
- Use C-III or C-III plus to clear any DTCs that may have stored.

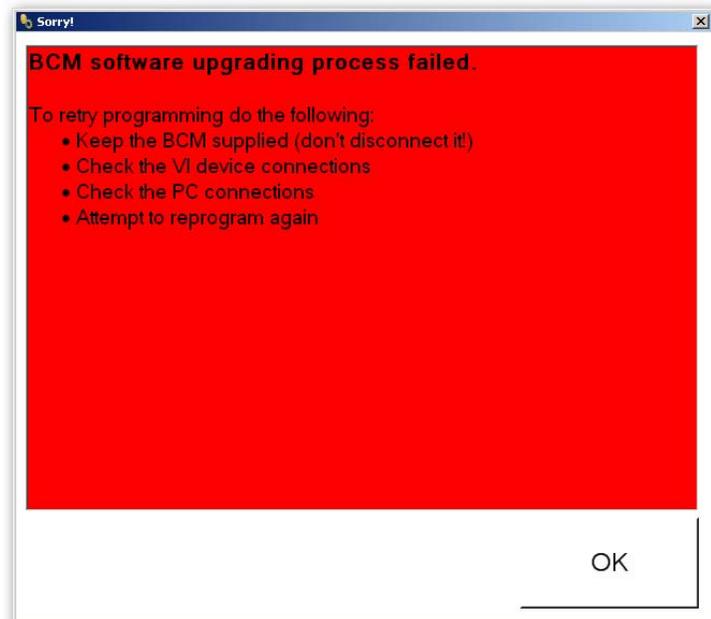
Error – BCM reprogramming failed (reprogramming did not complete correctly)

- The reprogramming process will stop and the message in Figure 4 will display.

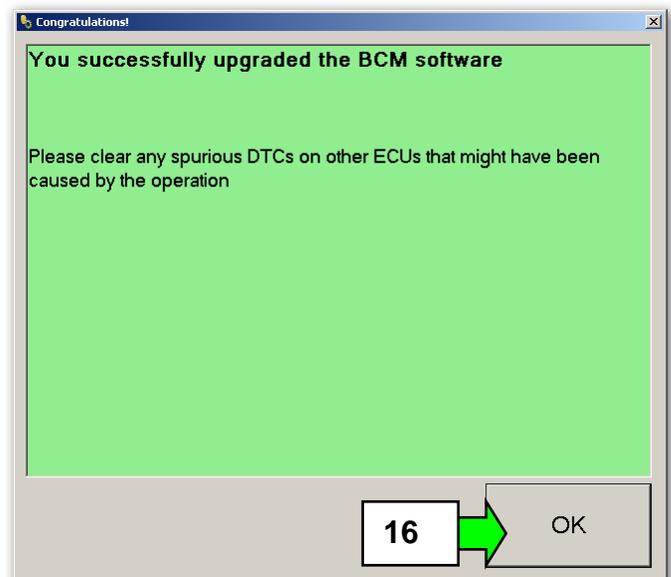
NOTE: When BCM reprogramming is complete the screen in Figure 5 displays and the hazard flashers will start flashing.

Refer to page 9 for the reprogram completion screen.

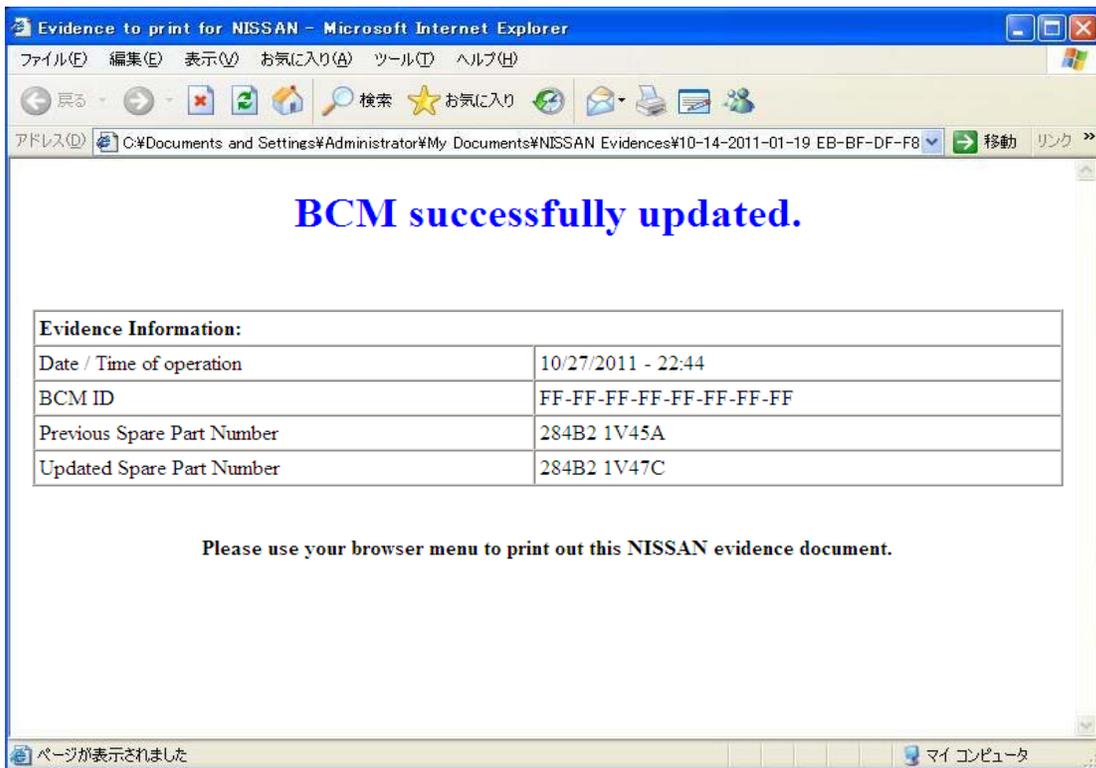
NOTE: When OK is selected, Internet Explorer will automatically launch and the screen in Figure 6 (shown on the next page) will display.

17. Print the Internet Explorer screen shown in Figure 6 and attach a copy to the repair order.
